application **Temporary Walls**
 location **Noisy River, Ontario, Canada**
 products **Geolon® HP570 (Armtex HS1400)**

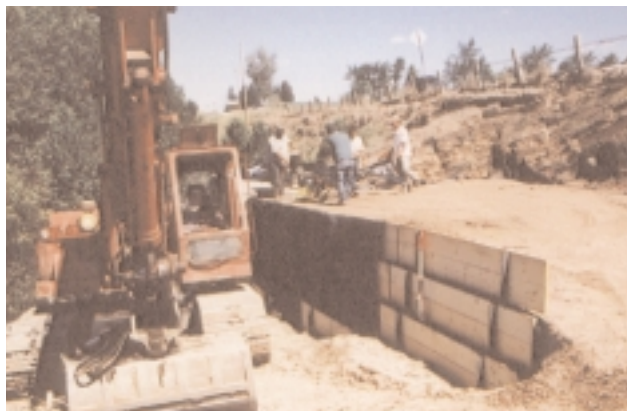
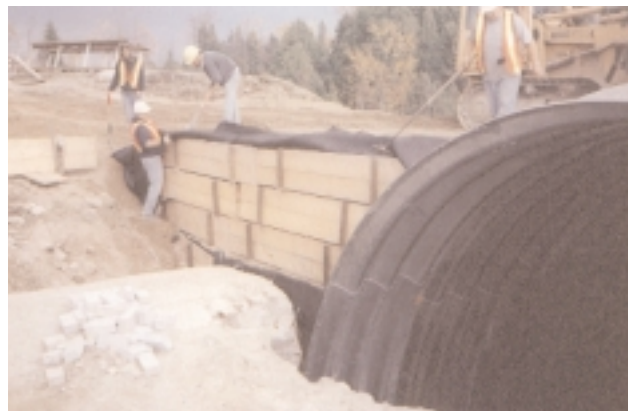
Backfilling of the structure started with construction of the second temporary wall. This wall was built in the same manner as the first wall, using granular fill and Geolon® HP570 (Armtec HS1400), compacted to 95%. Backfill was placed and compacted in 200mm (8 in) lifts.

The first 5.5 m (18 ft) high temporary wall was constructed beside and above the failing structure. With space on site extremely limited, the wall was required in order to safely provide for one lane of traffic within a half-length of the structure. Once this detour was
