Voids Bridging in Landfill

Marion County, Florida

Mirafi® HS500

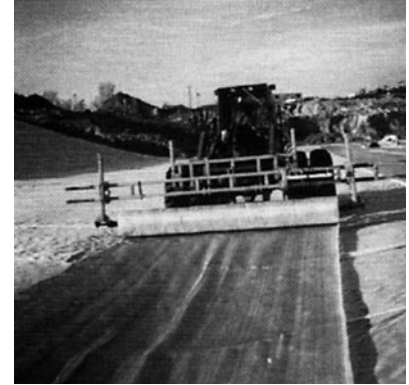
Deployment of HS500

Geotextile specification requirements called for a woven high strength polyester material which achieved a minimum average roll (MARV) ultimate wide width strip tensile strength of 77 kN/m (500 lbs/in) in the machine and cross-machine direction at 10% strain, determined using ASTM D 4595 test procedures.

Additionally, each layer required sewing of the individual rolls into one complete pane. This required that the two geotextile layers would be field fabricated to completely cover the site area. Seams were butterfly type stitched, with two parallel rows of stitchlines.

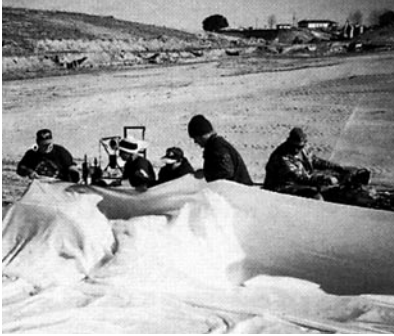
Seaming of HS500

All seams were sewn in the "up" position for visual inspection. High strength polyester sewing thread was used to sew the seams. Field sewing took approximately two months.
